# GENERATOR FIELD WINDING SHORTED TURN DETECTION TECHNOLOGY

Donald R. Albright, David J. Albright and James D. Albright  
Generatortech, Inc.

## ABSTRACT

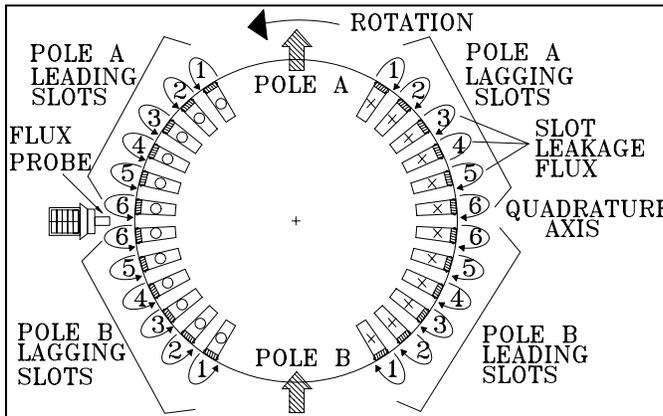
**FIGURE 1** – Two-pole rotor with 6 coils/pole showing the rotor coil and slot nomenclature.

Shorted-turns in coils near the quadrature axis in 2-pole rotors will have little effect on thermal sensitive balance because the effected slots are nearly 180° apart (**FIGURE 1**). Shorted-turns in the small coils (1, 2 or 3) of one pole will have a greater effect in causing rotor unbalance problems since the asymmetrical location will result in a larger rotor temperature gradient.

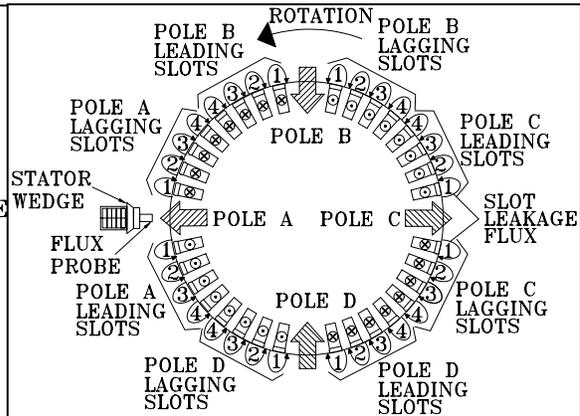
**FIGURE 2** – Four-pole rotor with 4 coils/pole showing the rotor coil and slot nomenclature.

Shorted turns in 4-pole rotors will also act to produce a thermal gradient (**FIGURE 2**). However, since 4-pole rotors tend to be stiffer than 2-pole rotors, thermal gradients tend to be less effective in producing rotor bowing.

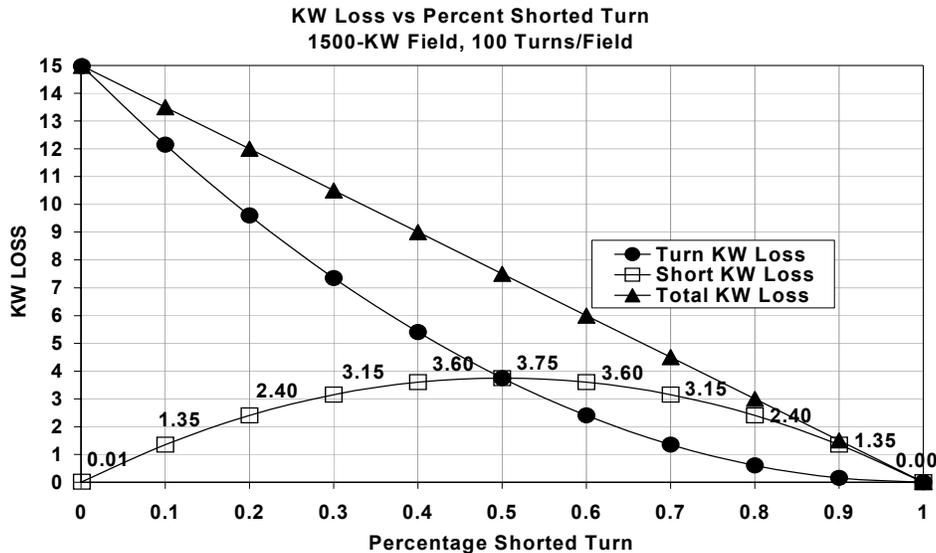
FIGURE 3 – Effect of a partial shorted turn on KW loss of one coil turn.

The establishment of a shorted turn may initially result in a partial turn short. However, calculations of the heat produced by the higher resistance of a partial shorted turn contact suggest that this condition cannot be maintained for long. **FIGURE 3** shows the KW loss for one turn of a 1500-KW field with 100 total turns that has been paralleled with varying percentages of a short circuit. Even at the level of a 10% shorted turn, the KW loss at the shorted turn contact is 1.35-KW. This amount of heat produced at a small contact point can easily exceed the melting point of the copper to produce a low resistance spot weld. The creation of a low resistance contact (full turn short) between turns will reduce the total KW loss for the

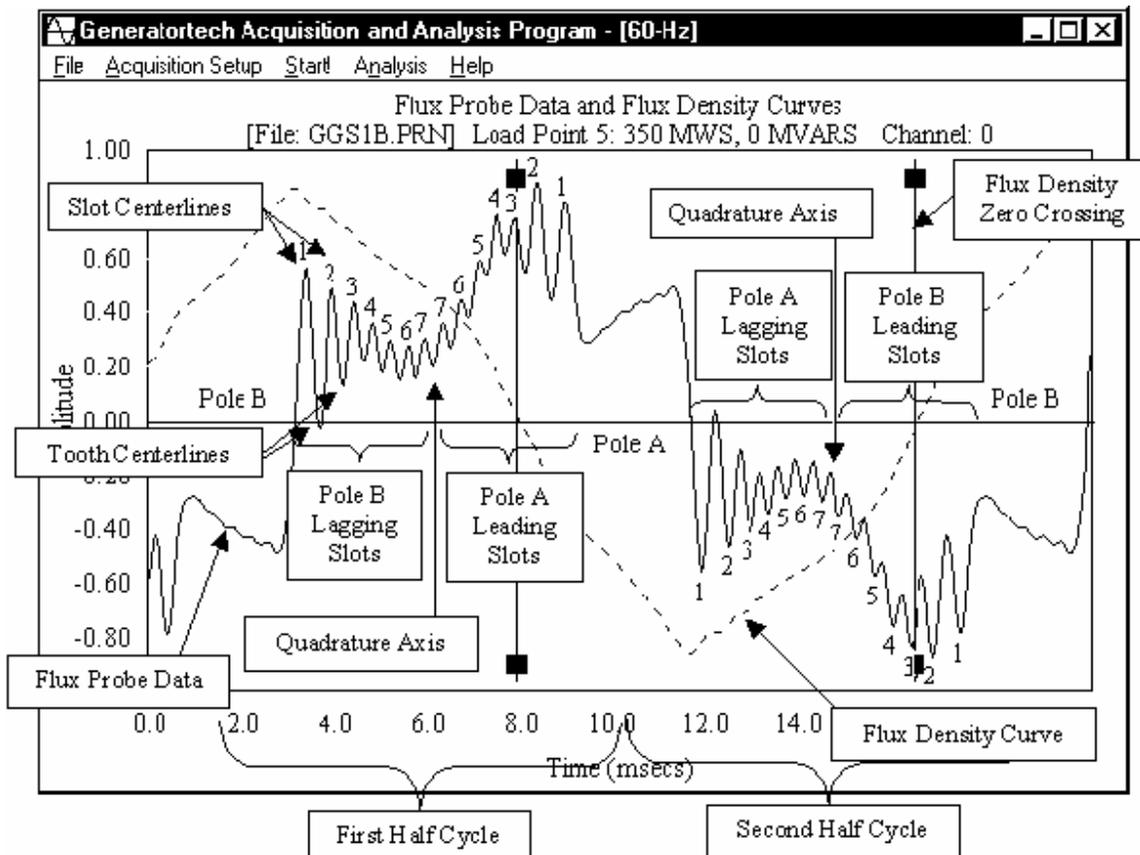
**FIGURE 4** – Flux probe data for a 7 coil/pole rotor illustrating important nomenclature

The flux probe is sensitive to the time rate-of-change of the radial flux in the air-gap. As each rotor slot passes the flux probe, the slot leakage flux from that slot is detected. The flux probe waveform displays a peak for each rotor slot (see **FIGURE 4**). The magnitude of that peak is related to the amp-turns in the slot. Since amp-turns are directly related to the number of active turns in the slot, a coil with shorted turns will display a smaller peak than a coil without shorted turns. By comparing slot peak magnitudes between poles, the number of shorted turns can be calculated for each coil in the rotor. To calculate the presence of symmetric shorted turns (same coil in all poles) requires comparison to a base set of data recorded before the development of the shorted turns.

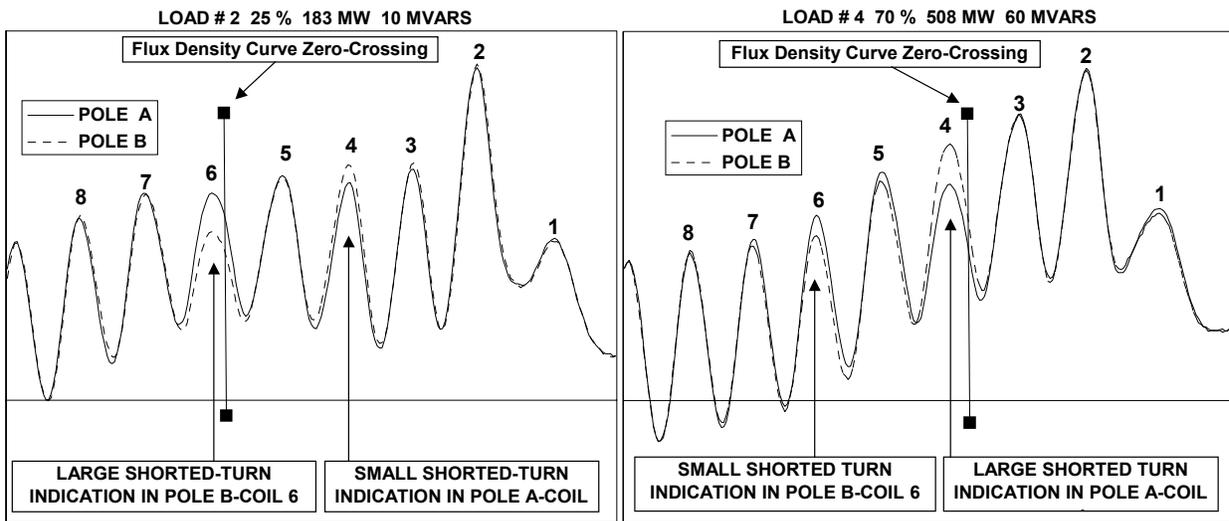
**FIGURE 5** –Flux Density Curve Zero-Crossing Position affect on shorted turn detection sensitivity. The rotor had 1 turn short in Pole A-Coil 4 and Pole B-Coil 6. Each coil has 6 total turns.

The first case study illustrates the effects of the flux density curve zero-crossing (FDZC) on shorted turn detection sensitivity. **FIGURE 5** displays two lead slot overlay graphs for a two-pole rotor with 1 shorted turn in both Pole A-Coil 4 and Pole B-Coil 6. The left graph is at 25% of full load and has a FDZC position near the lead slot of coil 6. The left graph shows a significant shorted turn indication for Pole B-Coil 6, however, the shorted turn indication for Pole A-Coil 4 is quite small. The right graph is at 70% of full load and has a FDZC position near the lead slot of coil 4. In this graph, the Pole B-Coil 6 indication has been reduced, while the Pole A-Coil 4 indication has been magnified. This example emphasizes the importance of recording a series of load points from zero to full load. It has been observed on many occasions that shorted turn indications would have been missed if only one load point was used for the entire analysis.

The waveforms displayed in **FIGURE 5** also show the effect of the use of magnetic rotor wedges. The #1 coil slots made use of magnetic wedges in this rotor. As can be seen in the graph, the #1 coil peaks are much reduced in amplitude relative to the other coil slot peaks.

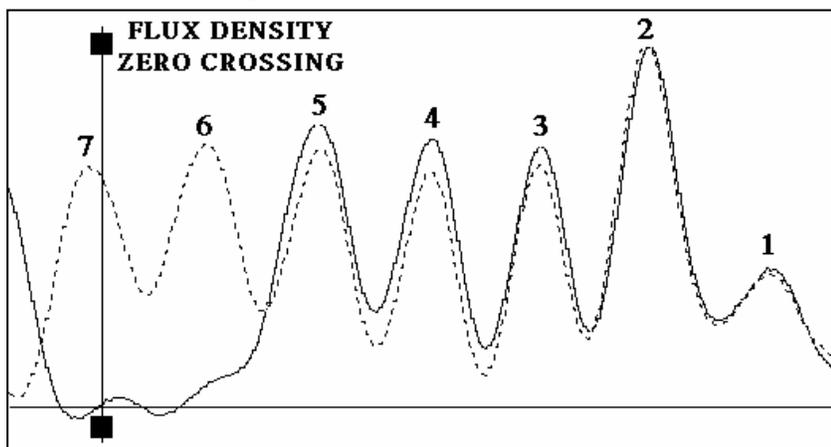
**FIGURE 6** – Overlay of lead slot data showing coils 6 and 7 of one pole completely shorted out of the circuit.

The second case study presents a two-pole rotor with 7 coils/pole in which coils 6 and 7 of one pole were shorted out of the field circuit. This result occurred when the top turns of coils 6 and 7 on one pole became shorted together. **FIGURE 6** displays this particularly severe case of shorted turns. The figure displays a dramatic absence of signal for the lead slots of coils 6 and 7 of one pole. The unit was only
